# EXISTING CONDITIONS TECHNICAL REPORT

Planning and Environment Linkages (PEL) Study I-80 over Mississippi River Rock Island County, IL and Scott County, IA P-92-002-18

**IDOT District 2** July 2020

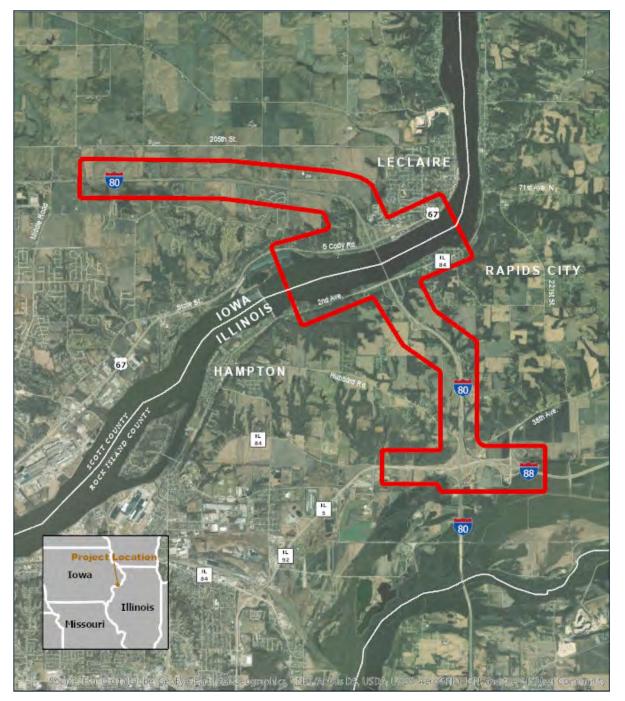
FIGURE 1 - PROJECT STUDY AREA

This Existing Conditions Technical Report (ECTR) is an essential part of Planning and Environmental Linkages (PEL) studies being undertaken for the project study area shown in **Figure 1**. This report introduces the project study area and provides a comprehensive understanding of conditions that currently exist. Existing conditions include roadway, drainage and bridge features, traffic operations and safety, and environmental, cultural, and socioeconomic resources. The study of existing conditions will identify key takeaways that will serve to guide the purpose and need development and alternative studies, and ultimately shape future improvements. The existing conditions presented in this ECTR represent a timeframe in the first quarter of year 2020.

Beginning in Illinois, the project study area (**Figure 1**) encompasses the entire I-80/I-88 system interchange in all directions: west along IL 5/IL 92 to Denhardt Road/193<sup>rd</sup> Street N, south along I-80 approximately 3,200 feet, and east along I-88 (Ronald Reagan Memorial Highway) to Old IL 2 (38th Avenue). Continuing north along I-80, the project study area includes southbound and northbound Weigh Stations, a Rest Area (Frontage Road) for southbound traffic, full interchange access to IL 84 (2<sup>nd</sup> Avenue), and along IL 84 (2<sup>nd</sup> Avenue) west to 180<sup>th</sup> Street N and east to 19<sup>th</sup> Street. Continuing across the Mississippi River into Iowa, the project study area includes full interchange access to US 67 (S Cody Road), and along US 67 (S Cody Road) west to Sycamore Drive/Canal Shore Drive SW and east to Eagle Ridge Road. The project study area continues north and west along I-80 crossing under SW 35<sup>th</sup> Street and crossing over Wells Ferry Road before ending just east of Middle Road interchange.

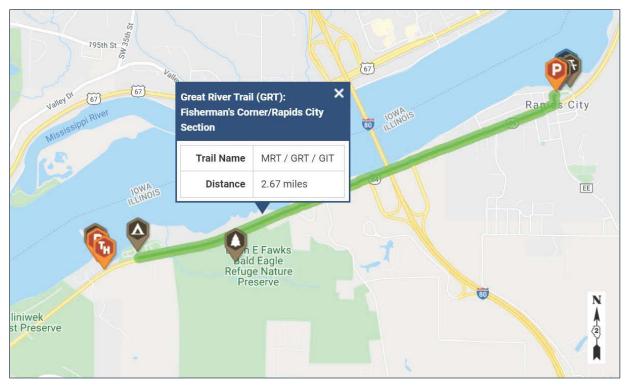
#### FIGURE 9 - GREAT RIVER TRAIL (GRT) LOCATION MAP

The only published trail or multi-use path within the project study area is the Great River Trail (GRT) on the Illinois side of the river between the BNSF railroad tracks and IL 84 (north side of IL 84) (**Figure 9**). This section of the GRT is referred to as the "Fisherman's Corner/ Rapids City Section". The trail is also part of the Mississippi River Trail (MRT) and Grand Illinois Trail (GIT). The GRT is the only bicycle and pedestrian friendly accommodations in the project study area.

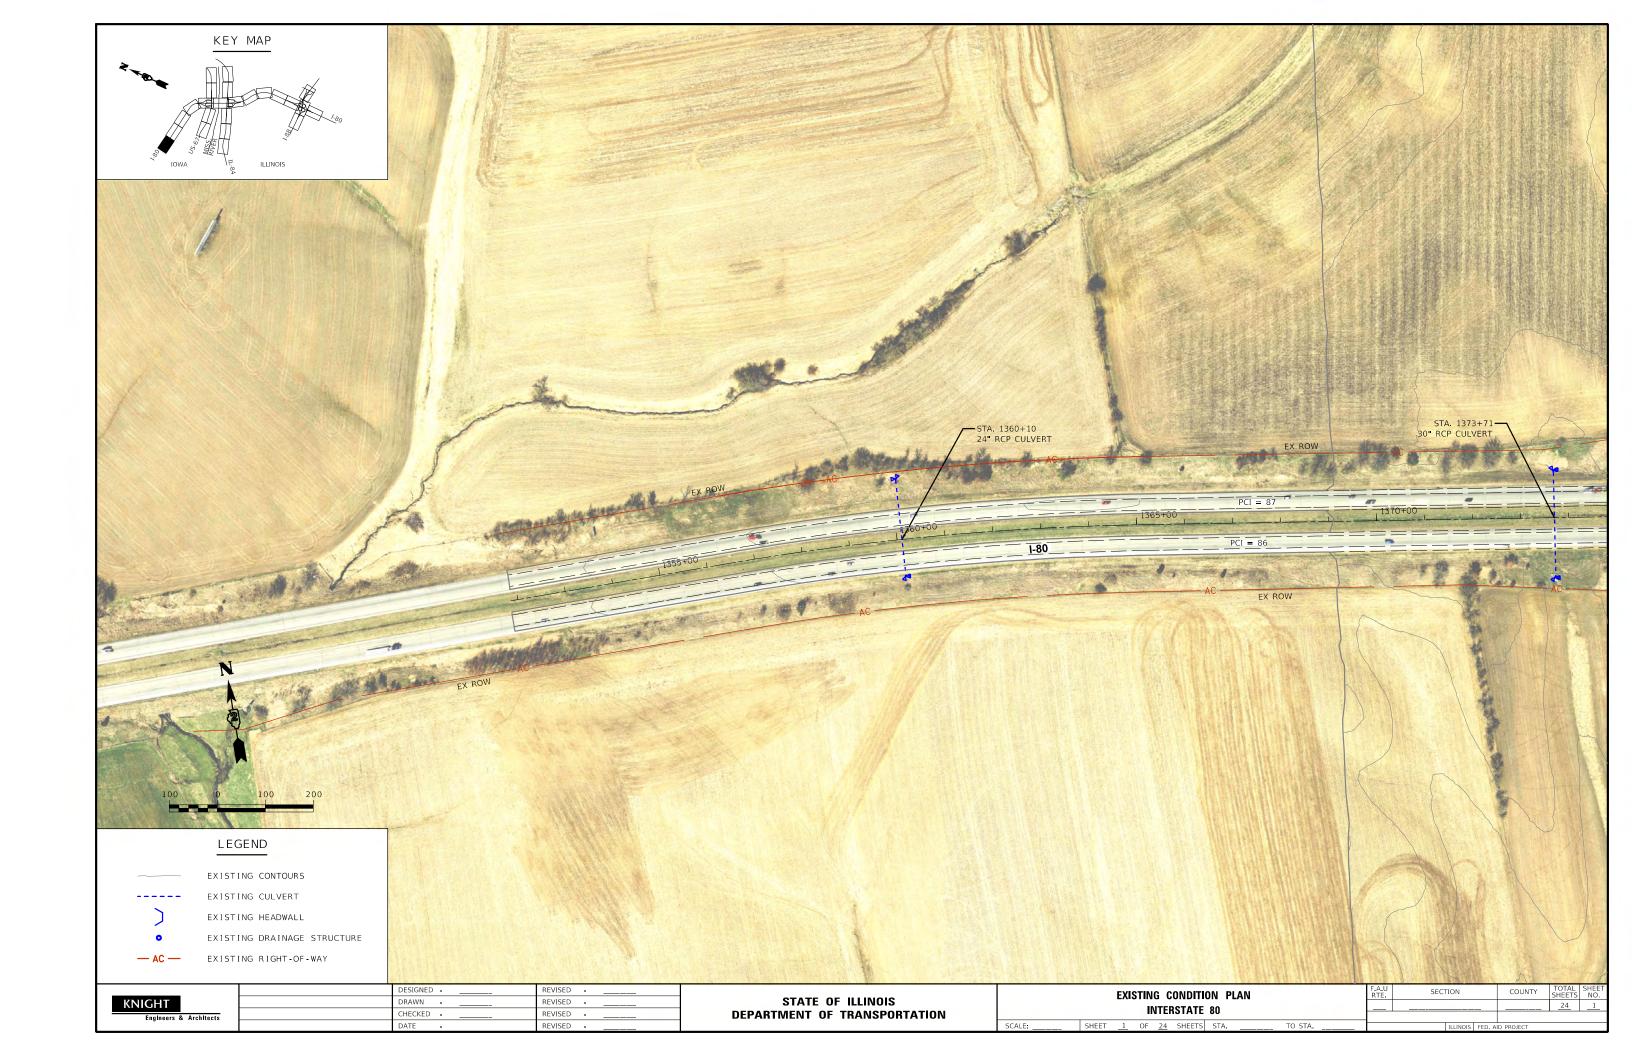
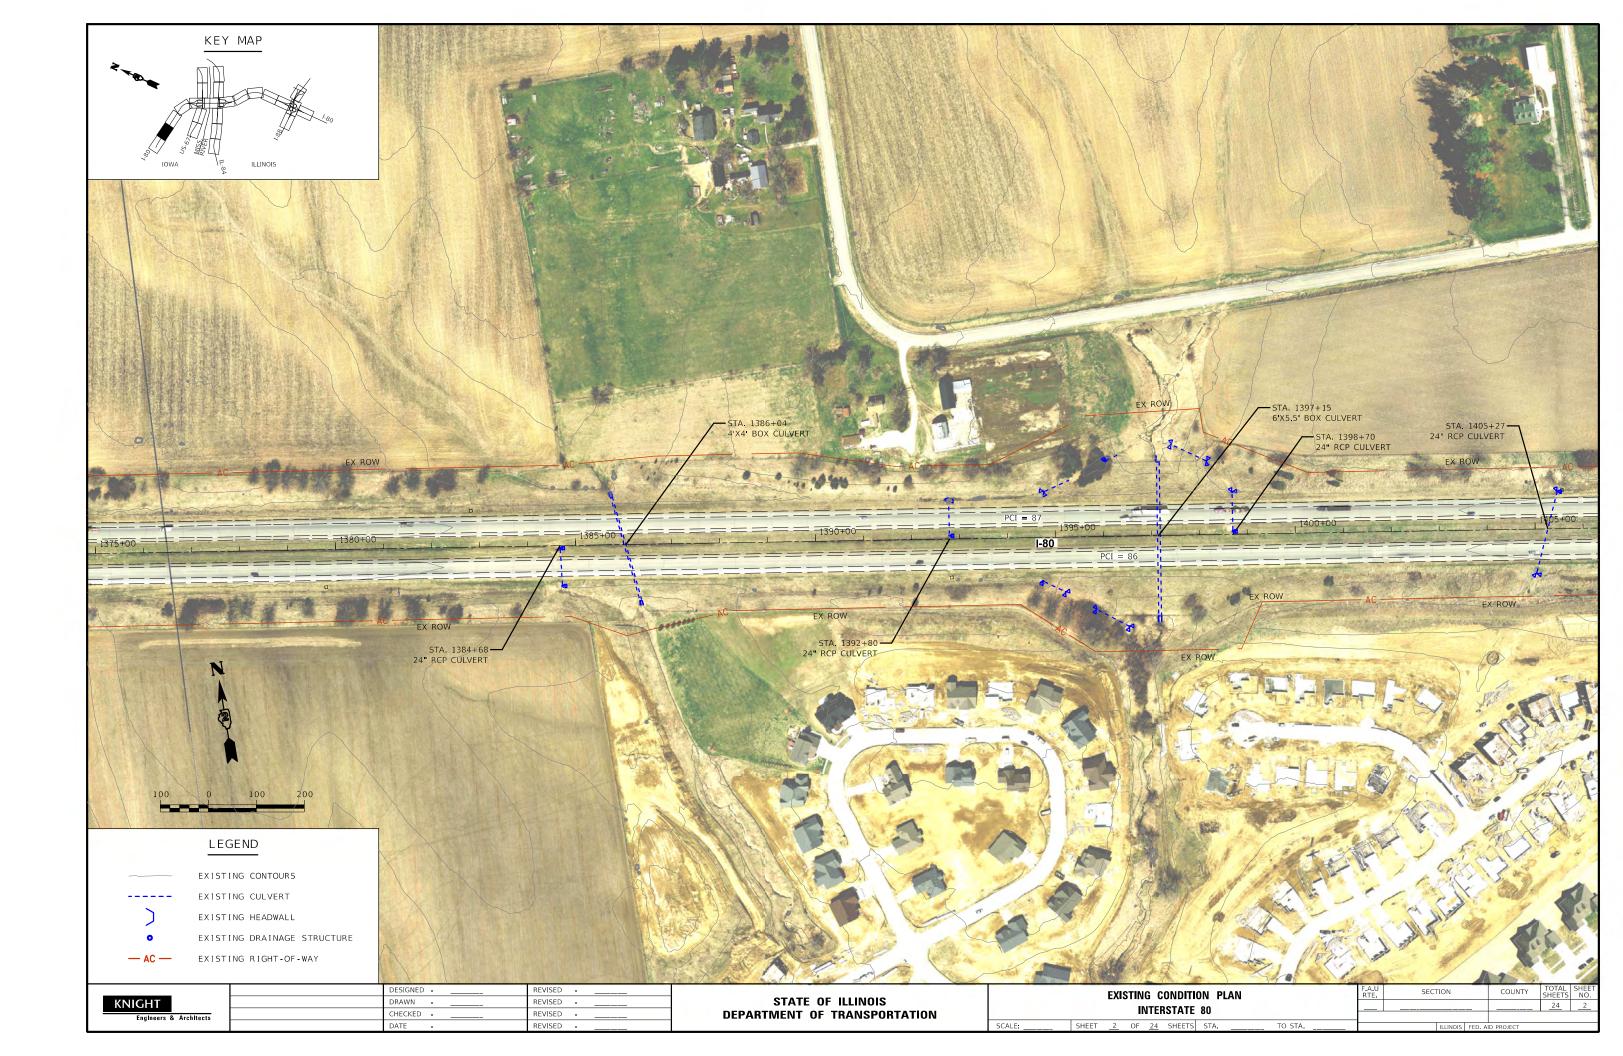
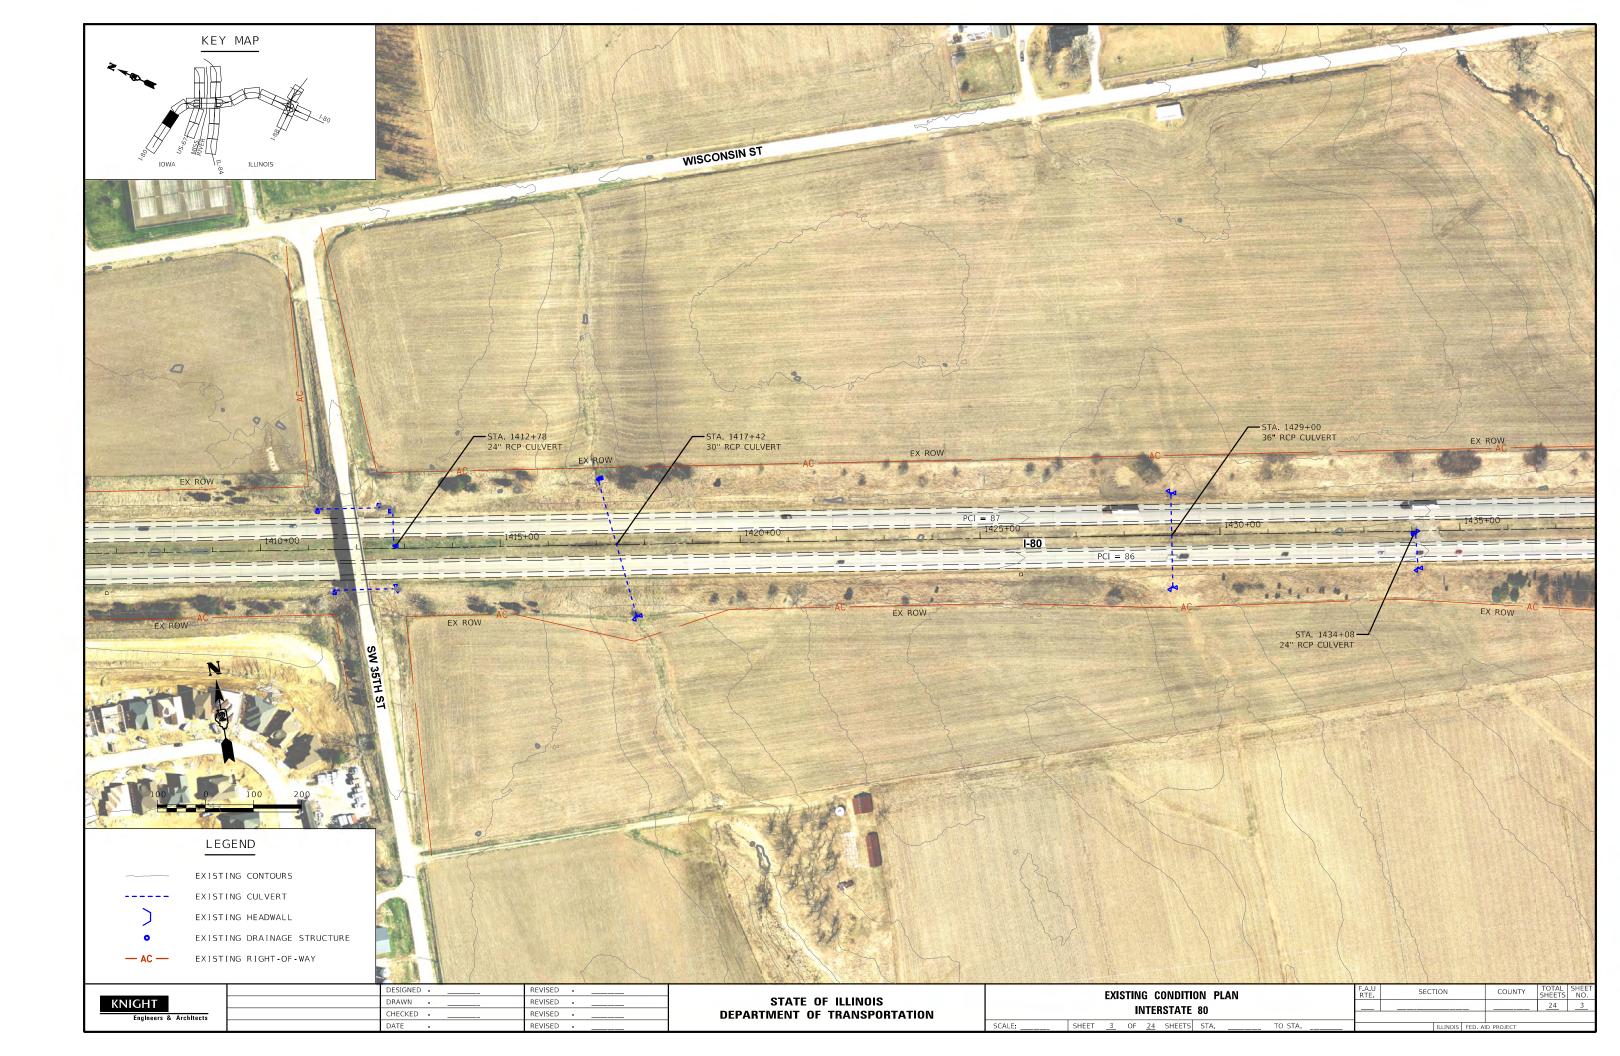
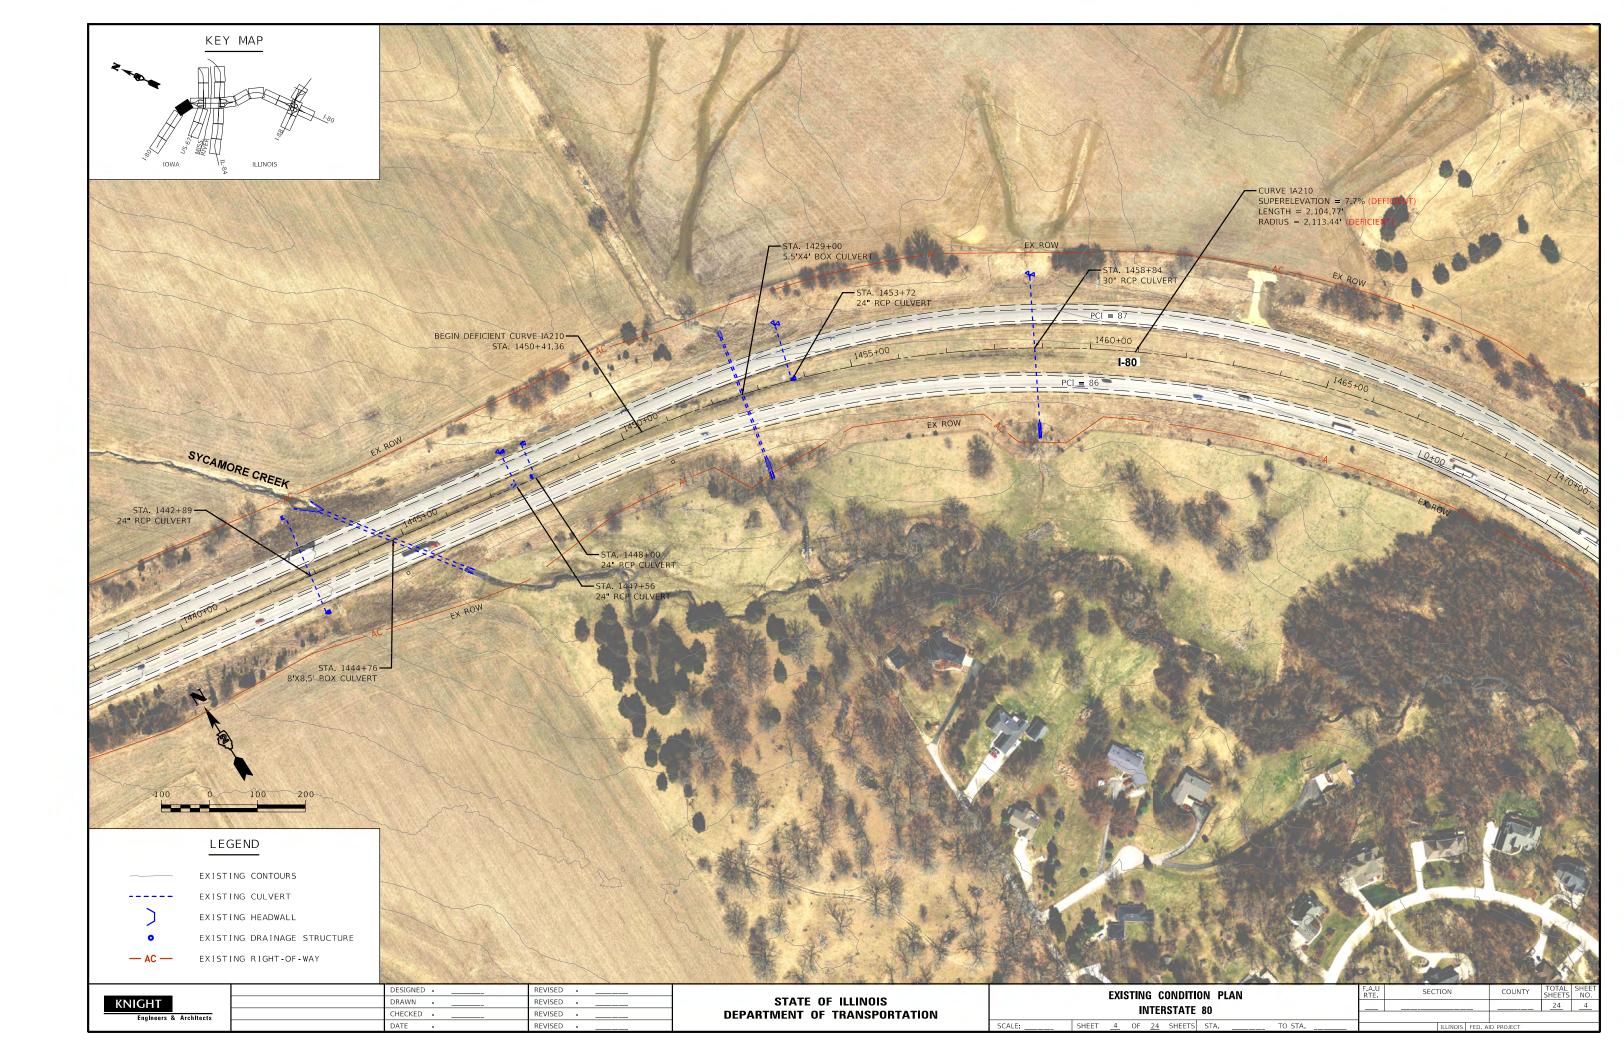
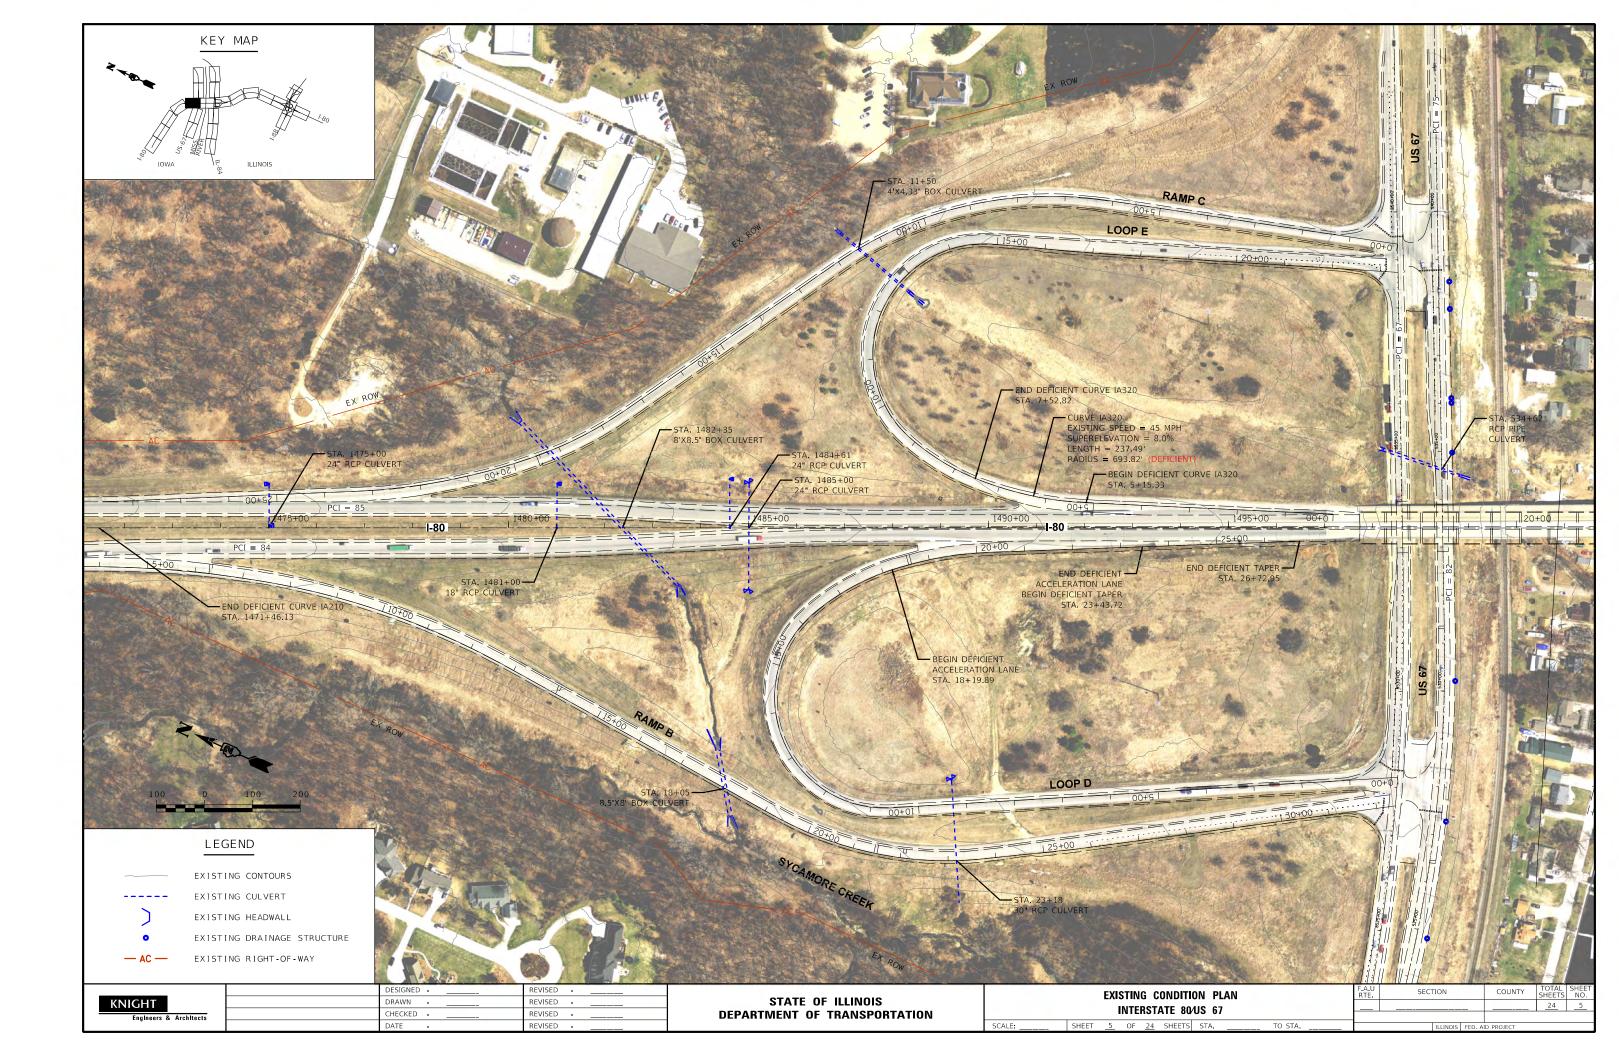
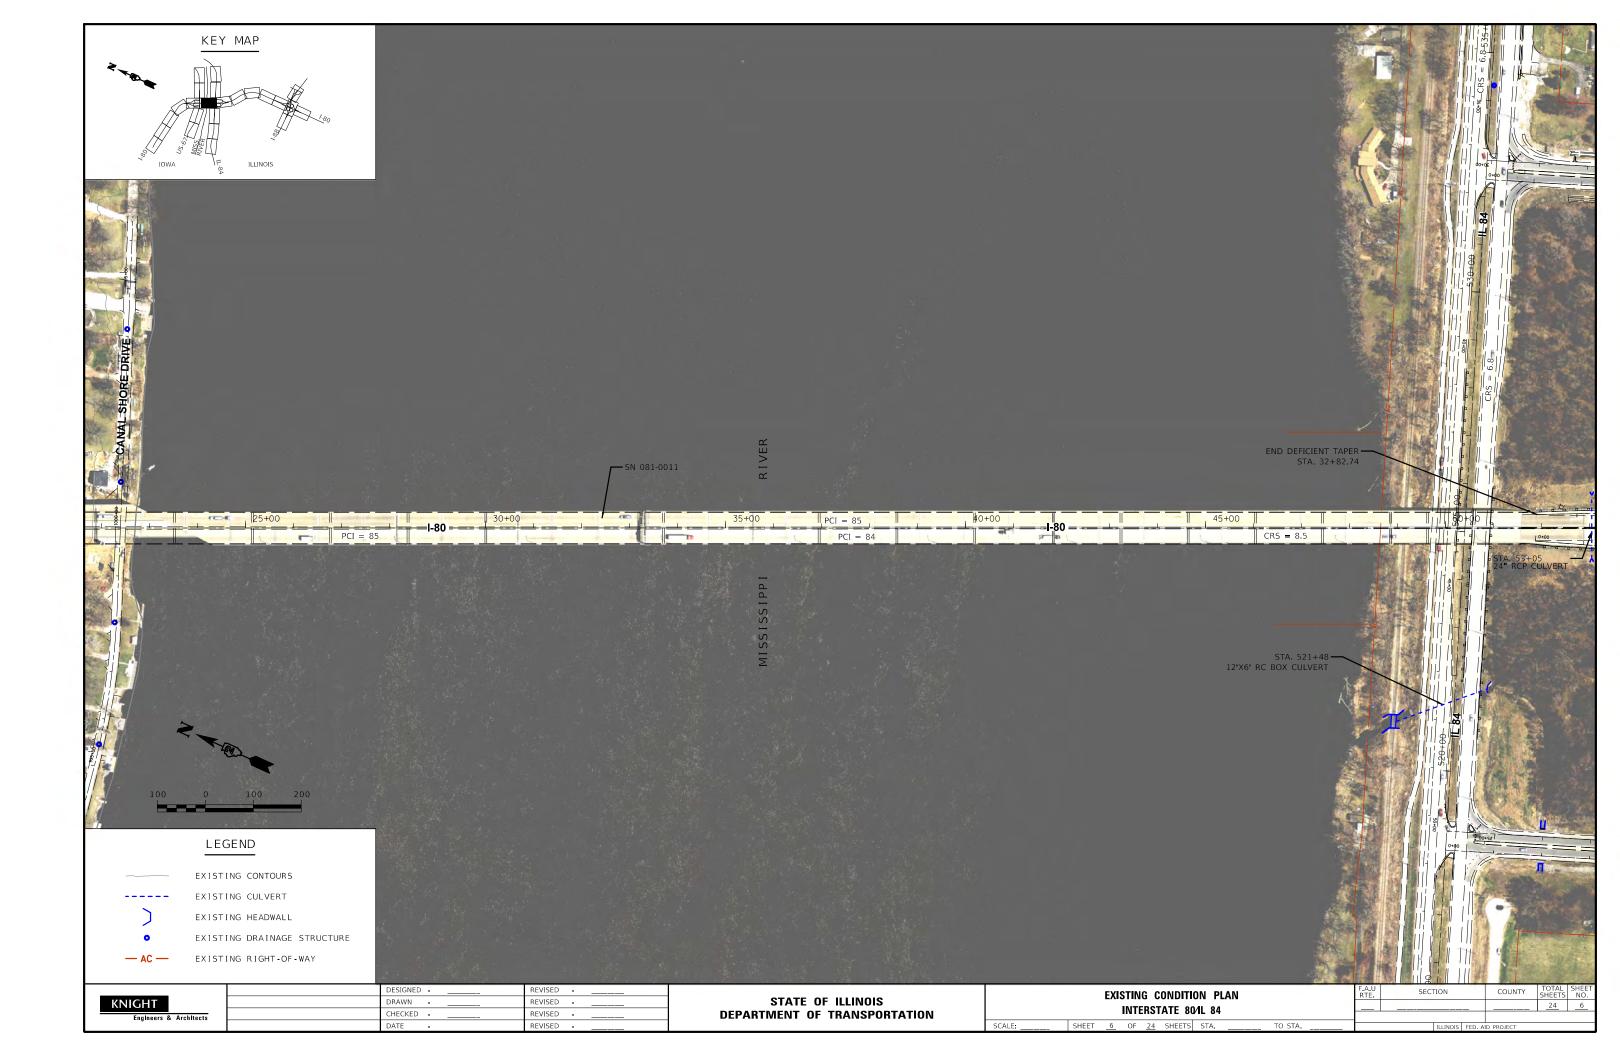
**Existing Condition Plans**

Attached as **Exhibit A** are "Existing Condition Plan" aerial exhibits that identify the various elements noted in the discussion below.

<u>Note</u>: The tabulated data that follows will highlight geometry that does not meet current design criteria for new construction/reconstruction as identified in the tables above. Only geometry that is deficient is tabulated below. The same deficiencies are also identified and noted on the "Existing Condition Plan" aerial exhibits attached as **Exhibit A**.

I-80 CRS figures vary from 8.1 and 8.5, which fall within the "Excellent" range. IL 84 CRS is rated at 6.8, which is classified as "Satisfactory". I-88 CRS figures vary from 6.9 and 7.6, which is considered "Satisfactory" to "Excellent". The CRS values are also identified and noted on the "Existing Condition Plan" aerial exhibits attached as **Exhibit A**.

I-80 PCI figures vary from 82 to 87, which is classified as "Excellent". US 67 PCI figures vary from 62 to 83, which is considered "Good" to "Excellent". The PCI values are also identified and noted on the "Existing Condition Plan" aerial exhibits attached as **Exhibit A**.

Existing Right-of-Way (ROW) and Access Control (AC) limits were developed based on record plan data and online GIS data. The ROW and AC limits are identified on the "Existing Condition Plan" aerial exhibits attached as **Exhibit A**. Given that the PEL predominately studies roadways on the interstate system, access is restricted by AC other than interchange access at IL 84, Frontage Road (Rest Area) (southbound only) and Old IL 2 (38th Avenue) in Illinois, and at US 67 in Iowa. Northbound and southbound ramp access is also provided along I-80 to the Weigh Station in Illinois.

**Table 13** and **Table 14** provide a summary of bridges and culverts within the project study area in Illinois and Iowa, respectively. The tables provide limited information extracted from the most recent bridge inspection reports. The condition ratings noted in the tables are limited to the deck, superstructure, and substructure along with the culvert rating as it applies. Other relevant data discussed in the reports will be described in the narrative that follows, such as inspector observations, geometric suitability, structure age, number of spans, and structure type. Structure locations are identified on the "Existing Condition Plan" aerial exhibits attached as **Exhibit A**.
