I-80 OVER MISSISSIPPI RIVER PLANNING AND ENVIRONMENT LINKAGES (PEL) PURPOSE AND NEED STATEMENT

1.0 Introduction

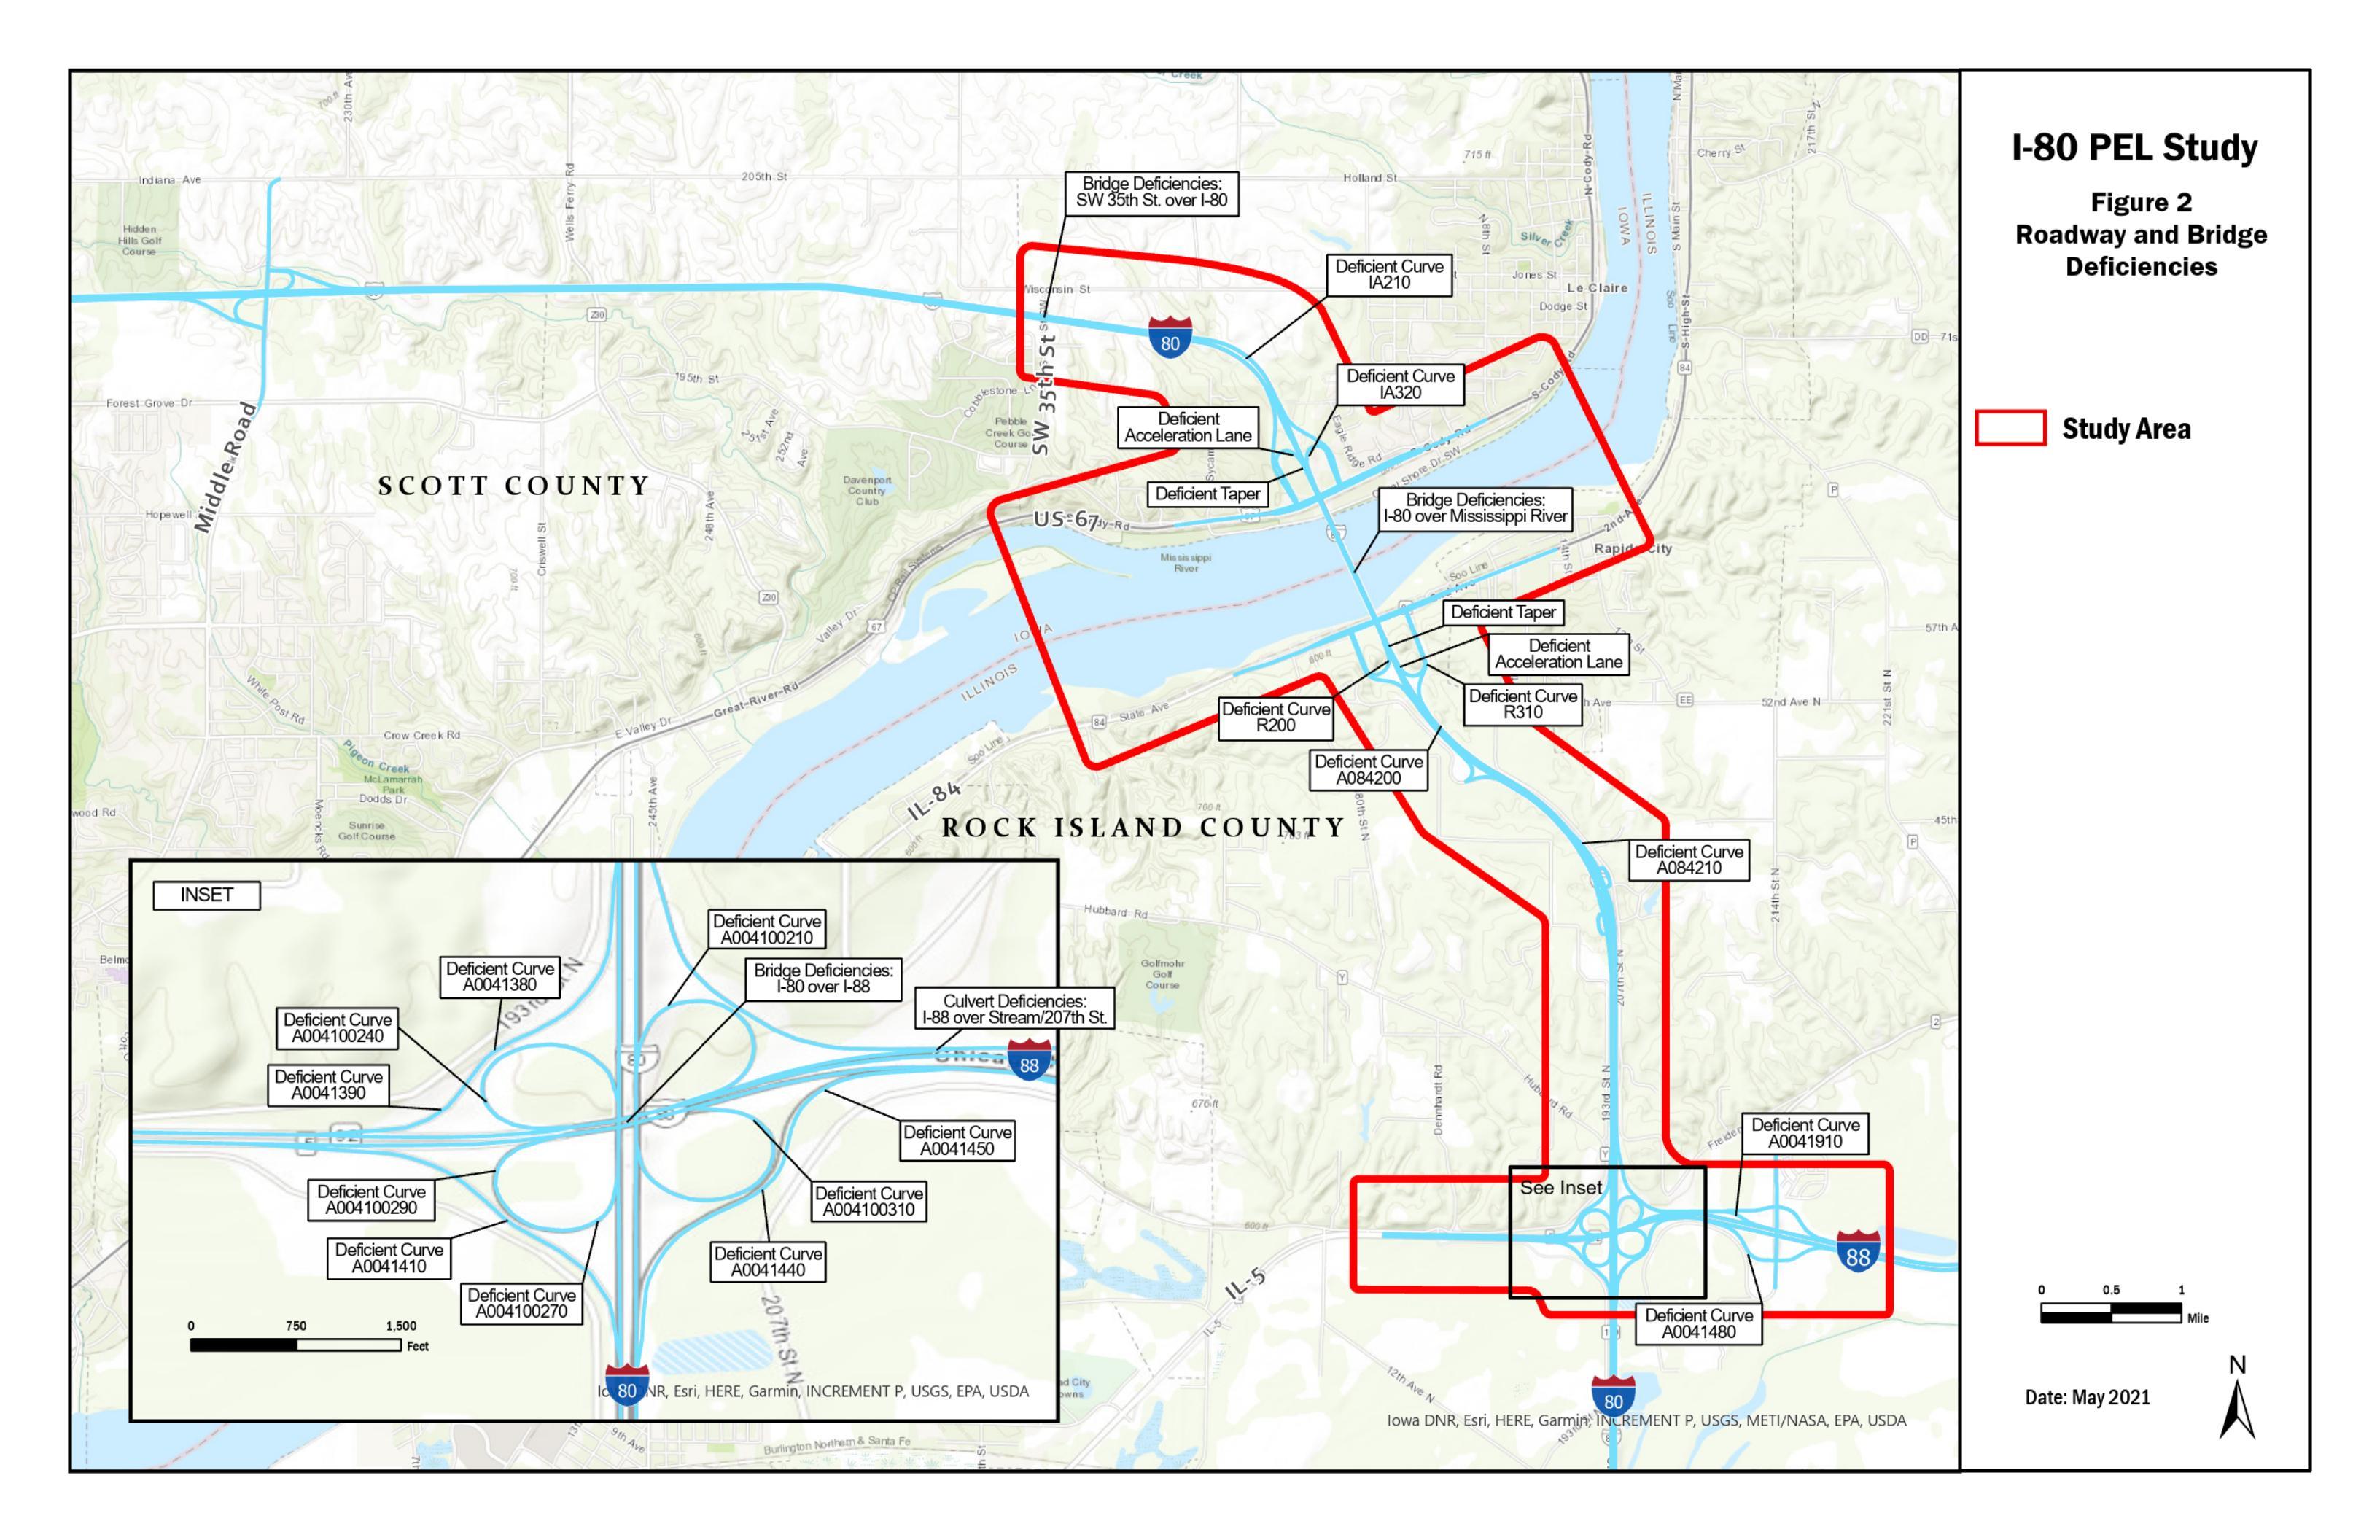
The following bridge deficiencies have been identified within the project study area. The locations of these bridge deficiencies are shown in **Figure 2**.

I-80 Mississippi River Bridge

- The bridge has substandard shoulder widths. The standard for inside and outside shoulder widths is 10 feet. The existing inside shoulder is one-foot wide, and the existing outside shoulder is five feet, 5 inches wide.

- The existing navigation span is 370 feet while the US Coast Guard (USCG) requires a minimum 420-foot-wide navigation span for new structures.
- The existing structure framing system is a non-redundant steel tension member two-girder system, which is also referred to as "fracture critical". This means that the bridge does not include extra redundant girders so if either one of the two main girders supporting the bridge would fracture it could lead to partial or total bridge collapse. Due to the potential severe consequences of a fatigue crack causing a fracture, the outside lanes of the bridge have been closed twice to traffic when fatigue cracks at critical locations have been identified. In 2008, the outside lanes of the bridge were closed for two months after inspectors found cracks in the steel under the bridge deck. In 2009, cracks in the bridge forced IDOT to close the bridge again in a similar fashion for several months. Since I-80 is a key truck route across the Mississippi River, these bridge closures had a substantial impact on traffic flow as traffic rerouted to I-74 and I-280 to the west. The FHWA discourages the use of this type of two-girder framing system for new structures.

- Scour (i.e., erosion of the riverbed around the pier footings) has exposed the bottom of footings at piers 11, 16, and 18. The footings for this bridge are exposed footings that sit on the riverbed. Scour is the action of flowing water that erodes the riverbed. When flowing water hits the footing, the water is redirected in all directions including down and erodes the riverbed. A scour hole that becomes large enough will undermine the footing and cause it to fail. Time has shown that the rock of the riverbed at this location cannot be relied upon to resist scour over the life of the bridge. The partially exposed footings at piers 11, 16, and 18 have been found to develop scour holes which has led to partial undermining of the footings. Spread footings on rock may remain a viable foundation concept in principle, but they need to be implemented differently. The bottom of footing needs to be set deeper, and complete burial of the footing in the riverbed may be an appropriate scour counter measure. (Alternatively, the use of deep foundations such as drilled shafts socketed into deeper rock may be preferred.)

- The existing footings of piers 9 through 13 and 15 through 23 are exposed above the riverbed as part of the original design. As noted above, this is not preferred according to current design standards because these footings are more susceptible to scour. Footings that are buried beneath the riverbed provide better protection to the footing from scour.

- Seat lengths for the bridge abutments and intermediate hinges are inadequate to meet current design standards. Seat length is the length of overlap between the girder and the seat. The locations of inadequate support length are at the abutments and the in-span hinges. When seat length is insufficient, the displacements which result from moderate earthquake shaking can cause the bridge girders to fall from their supporting seats completely, resulting in total loss of the span. When modern seat length criteria are met, even if shaking damages or overturns a bearing element between the girder and the seat, the bridge superstructure unit can remain supported on the seat without total collapse.

The horizontal curve on the lowa side does not meet the design criteria. According to the lowa Design Manual Section 1C-1, the minimum curve radius at a 75-mph design speed is 2,210'. The existing radius is 2,113.44', which is deficient due to being less than the minimum radius. The existing superelevation rate for Curve IA210 is 7.7%, which meets the maximum criteria of 8%. However, the radius associated with this curve is 2,113.44'. According to the Iowa DOT Design Manual Section 2A-3 Table 9, the superelevation is required to be 8% at the minimum required radius. Since the existing radius is even less than the minimum radius, the existing 7.7% superelevation is considered deficient. **Table 1** identifies deficient geometry along I-80 in Illinois and Iowa. **Figure 2** shows the locations of all the roadway geometric deficiencies within the project study area.

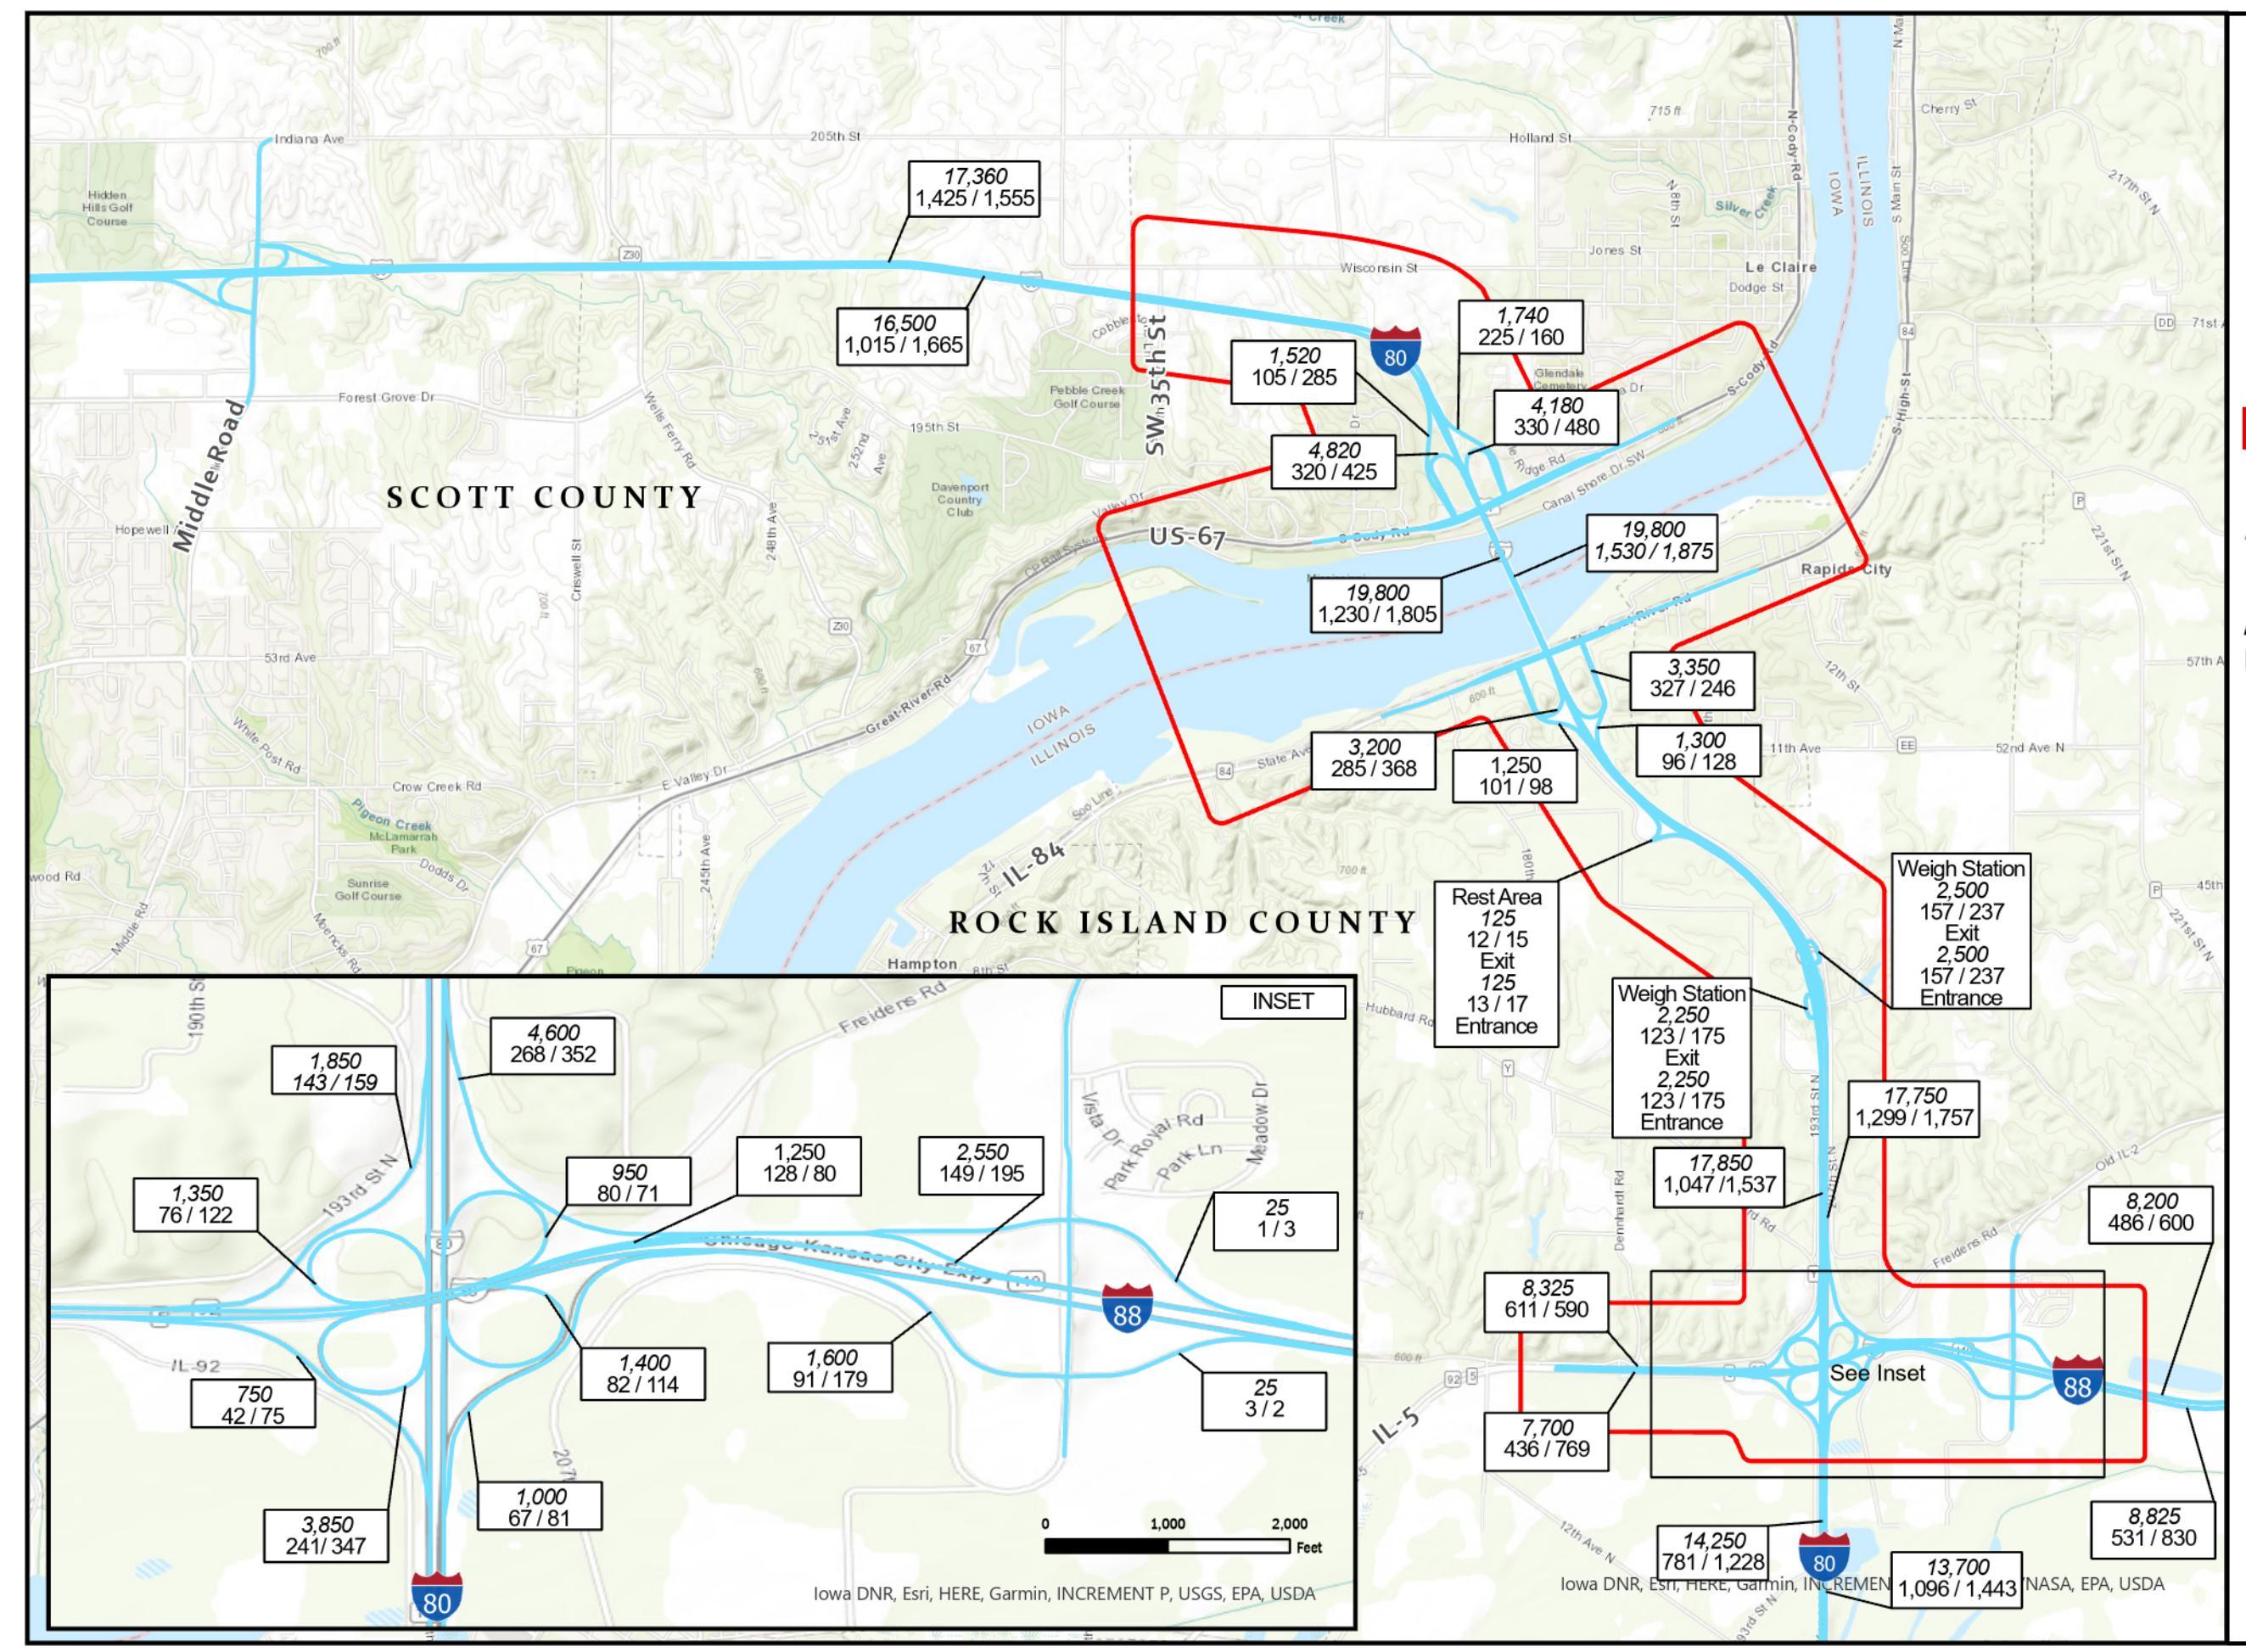
I-80 PEL Study Figure 3 Existing Traffic

Volumes

17,310 Annual Average Daily Traffic

1,000 / 1,000 -AM Peak-Hour Volume / PM Peak-Hour Volume

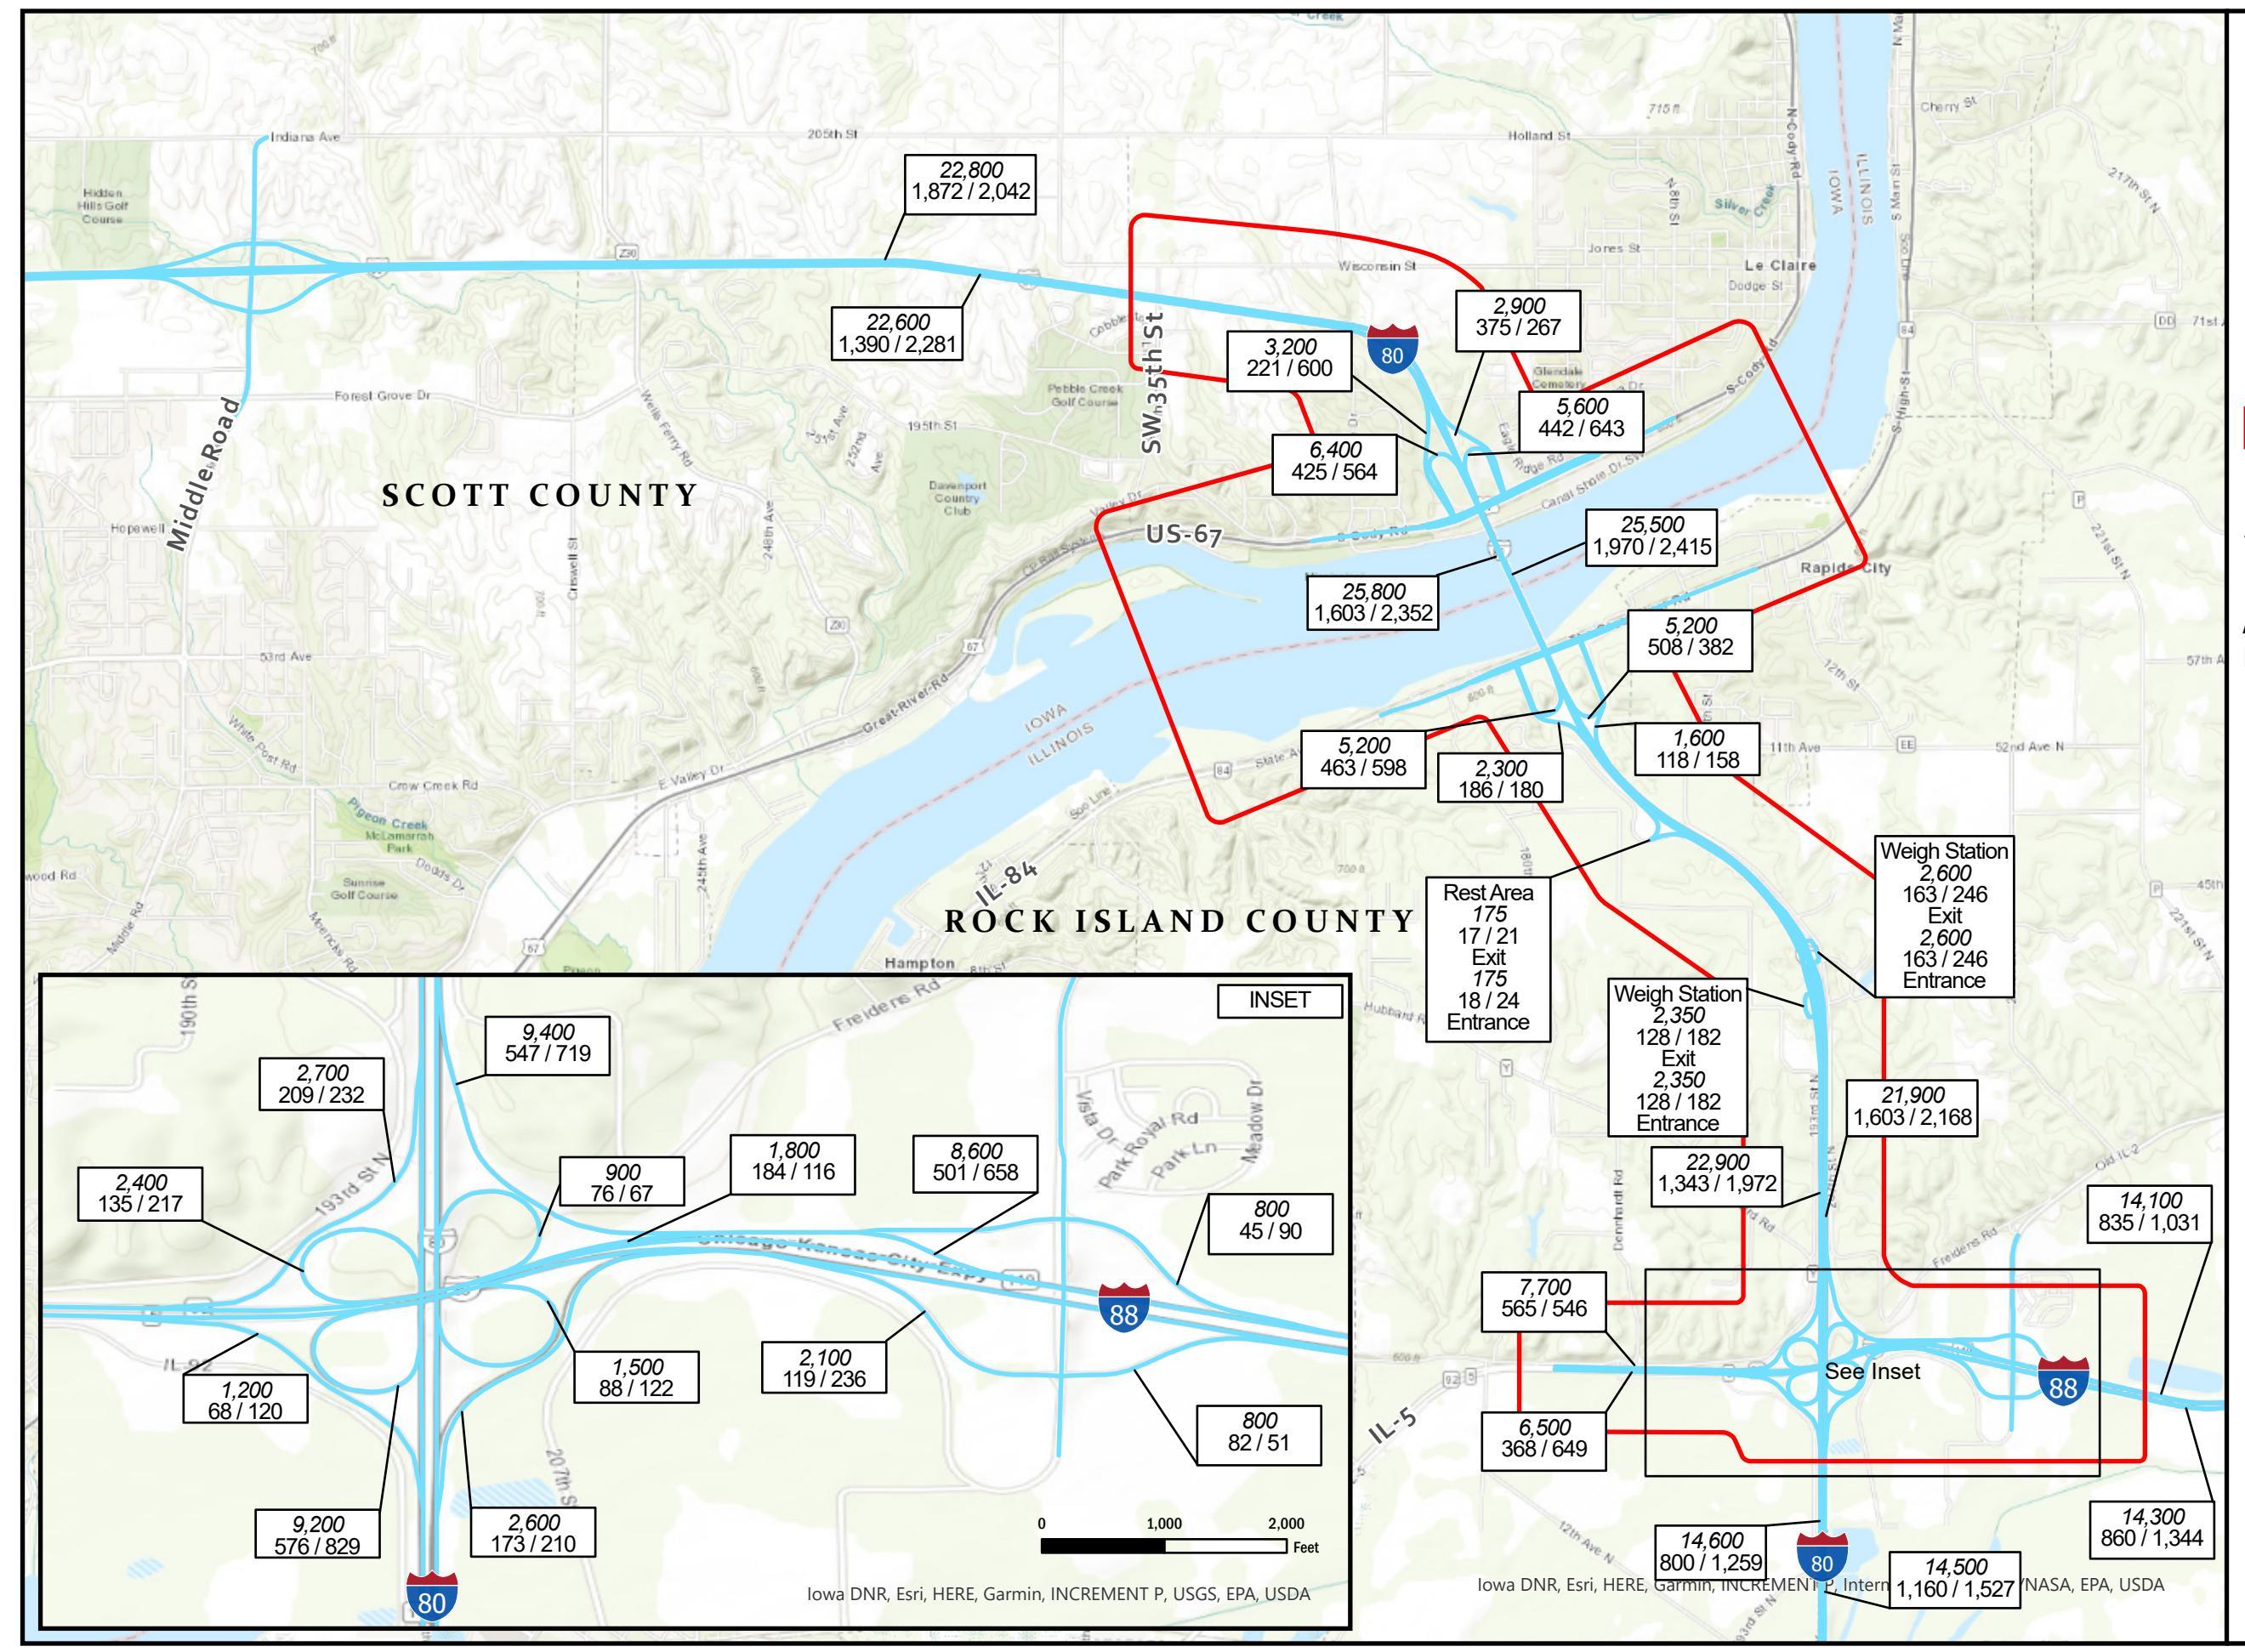
I-80 PEL Study Figure 4 Future (2050) Traffic Volumes

17,310 Annual Average Daily Traffic

1,000 / 1,000 -AM Peak-Hour Volume / PM Peak-Hour Volume

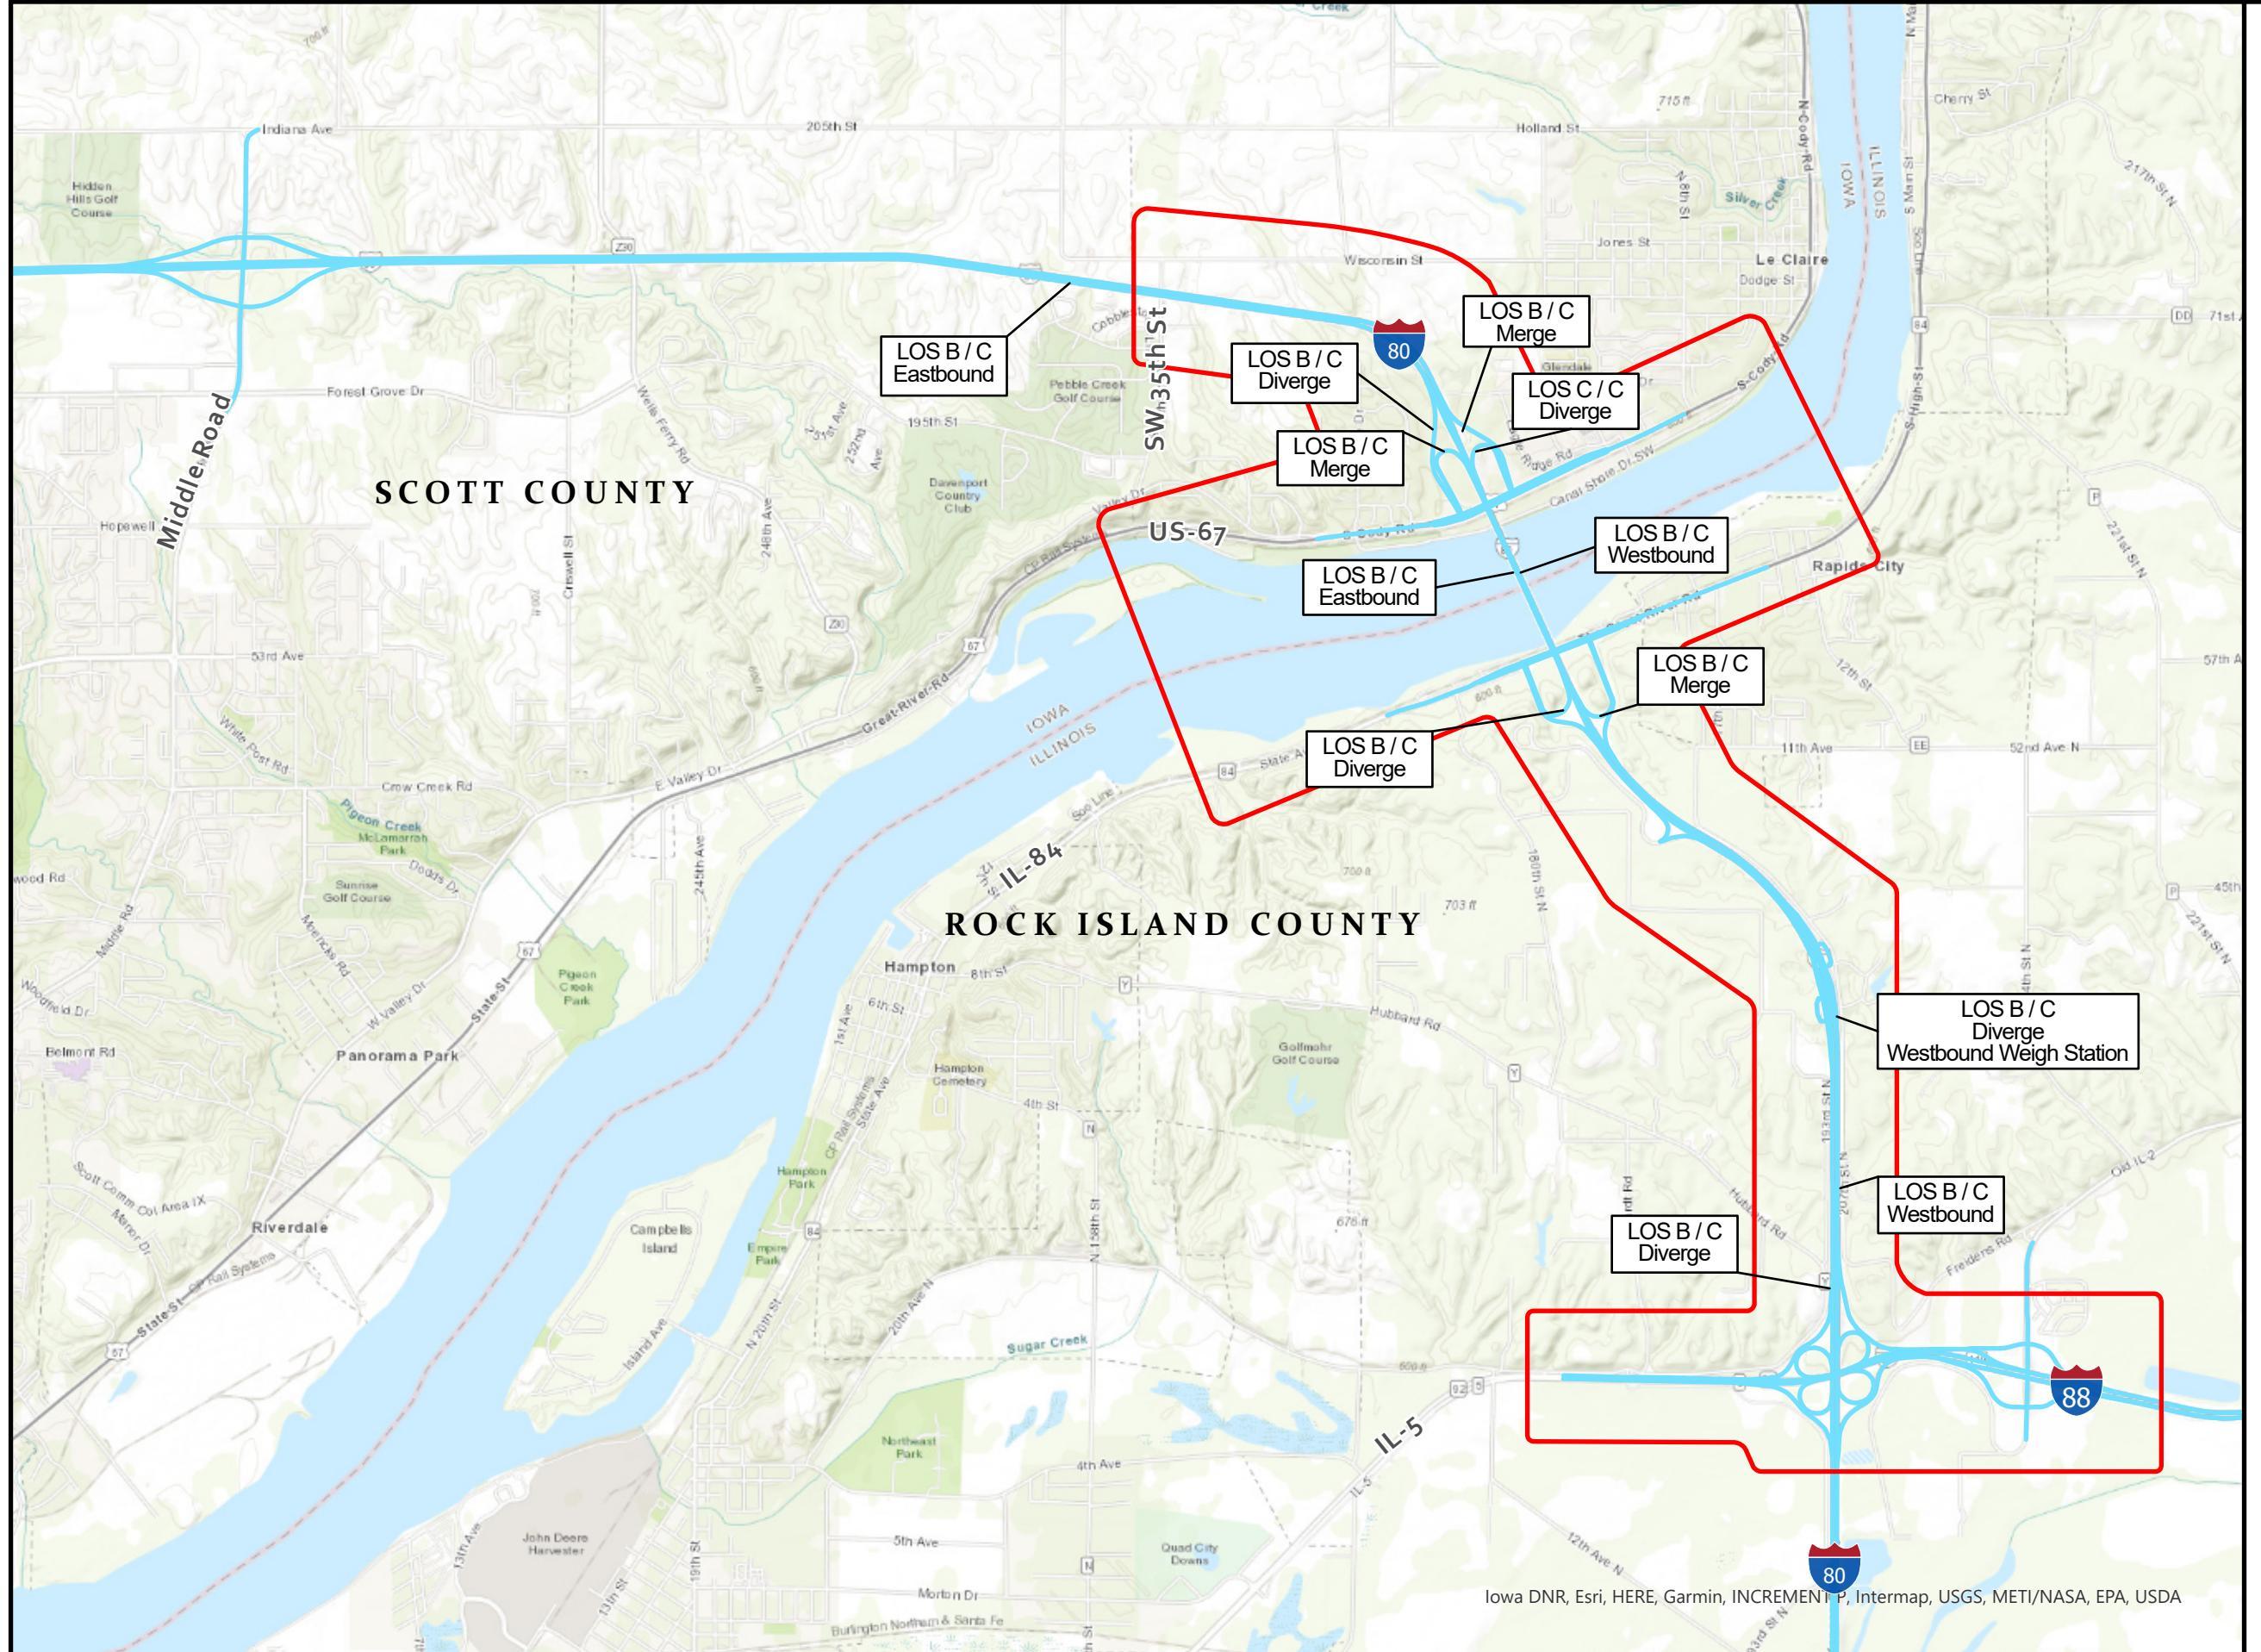
Figure 5 Sections with Future (2050) Level of Service C

Most of the sections are expected to operate at LOS A or LOS B in the future no-build conditions, with one section expected to operate at LOS C in the AM and 12 sections expected to operate at LOS C in the PM. LOS C meets the design standard for urban interstates. **Figure 5** and **Table 6** present the sections with LOS C. These sections include four freeway sections, including the eastbound and westbound sections of the I-80 bridge over the Mississippi River, the I-80 diverge and merge sections of the US 67 and IL 84 interchanges, the I-80 westbound diverge section at the weigh station, and the I-80 eastbound diverge to IL 5/92 westbound.

LOS AM/PM

Merge/Diverge/Weave -Denotes type of HCS analysis. All others basic freeway sections

Route	Direction	At	Туре	L	DS
				AM	РМ
I-80	EB	Middle Rd to US-67	Freeway	В	С
I-80	EB	US-67	Diverge	В	С
I-80	EB	US-67	Merge	В	С
I-80	WB	US-67	Diverge	С	С
I-80	WB	US-67	Merge	В	С
I-80	WB	US-67 to IL-84	Freeway	В	С
I-80	EB	IL-84 to US-67	Freeway	В	С
I-80	EB	IL-84	Diverge	В	С
I-80	WB	IL-84	Merge	В	С
I-80	WB	Weigh Station	Diverge	В	С
I-80	WB	I-88 to Weigh Station	Freeway	В	С
I-80	EB	IL-5/92 WB	Diverge	В	С

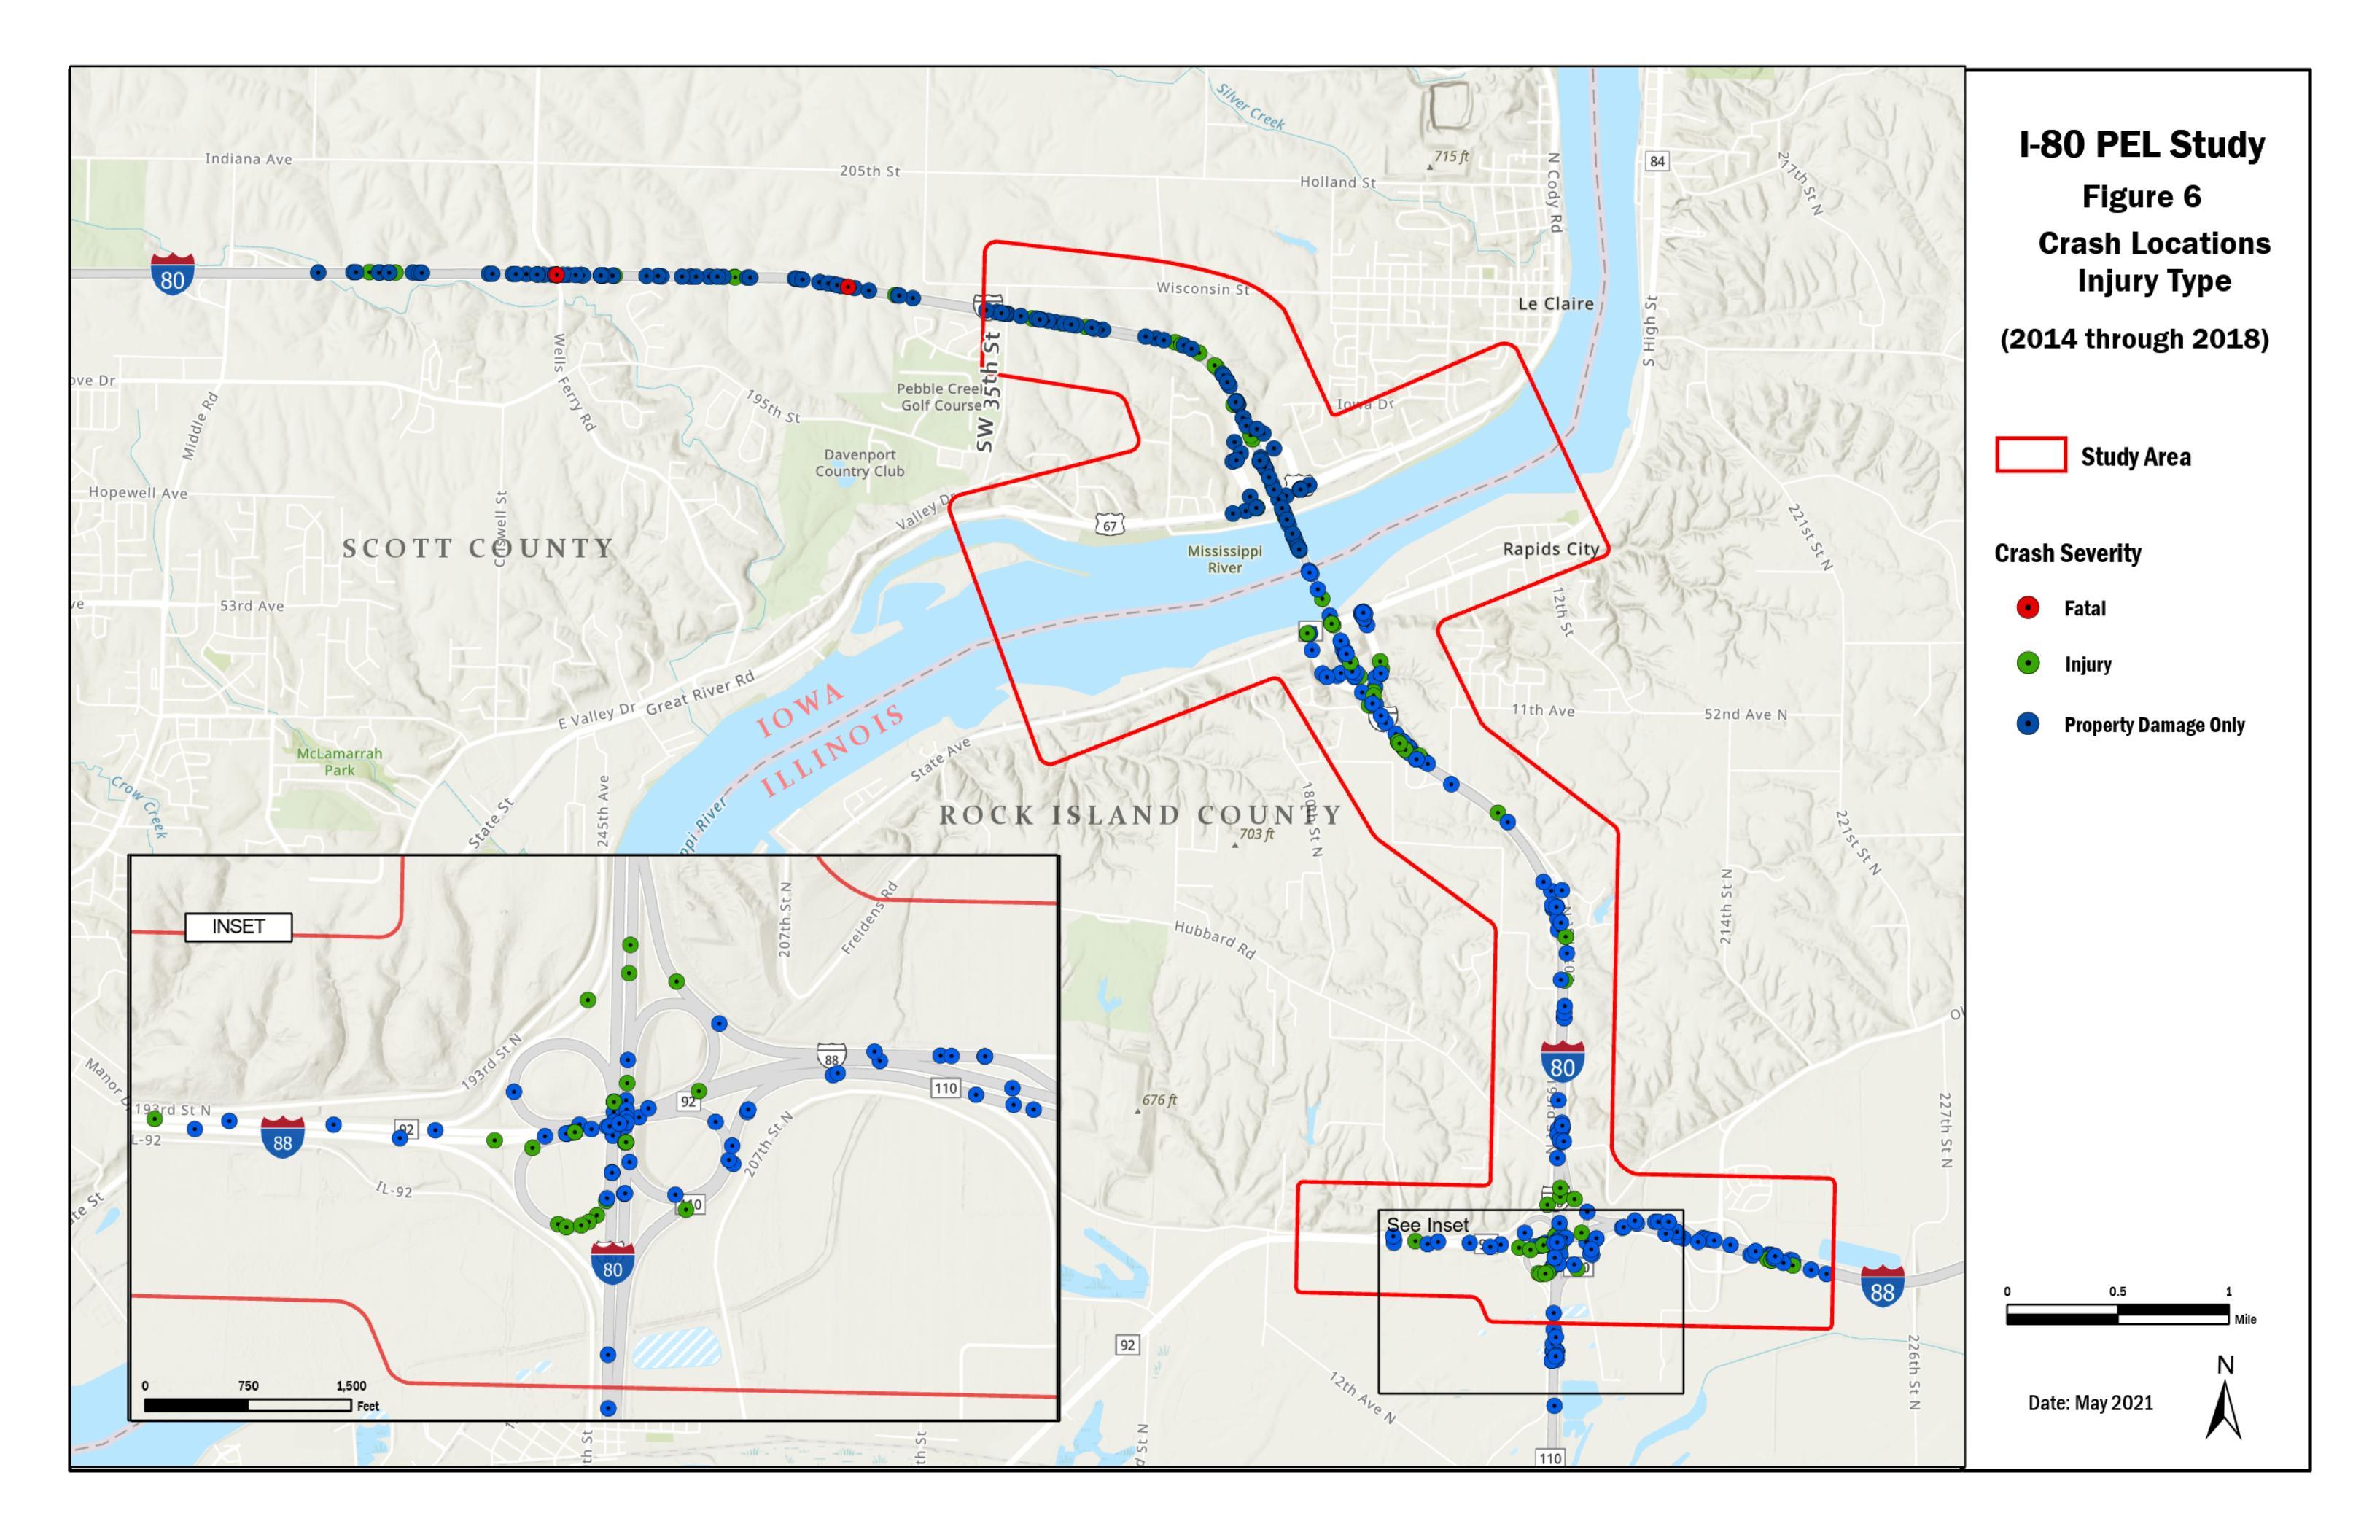
Crashes in Illinois and Iowa were analyzed for the years 2014 through 2018. **Figure 6** shows the locations of these crashes. The crash data was evaluated to determine if there are any concentrations of crashes and/or trends in crash types and if there are any correlations with the roadway and bridge geometric deficiencies that were previously identified in Section 1.1.1 and 1,1.2. The results of this evaluation are also presented in **Table 7** and **Figure 7** (Note: Animal-related crashes were not counted because it was assumed that they were not associated with any geometric deficiencies). Based on this evaluation, the following most notable crash trends were identified.

- I-80/US 67 Eastbound Ramp Intersection Twelve crashes occurred at this signalized intersection, most of which
 involved rear-end collisions. There are no roadway geometric deficiencies associated with this interchange so the
 cause of these crashes is undetermined.

- I-80 Bridge Over the Mississippi A total of 29 crashes occurred on the bridge with 75% (i.e., 22) of the crashes occurring on the lowa side. The cause of the higher number of crashes on the lowa side is undetermined. No notable trends were identified regarding crash types but a number of these crashes (e.g., vehicles hitting the concrete barrier) could have been attributed to the substandard/narrow shoulders.

- I-80/IL 84 Westbound Ramp Intersection Eighteen crashes occurred at this unsignalized intersection on IL 84 and four occurred on the off-ramp approaching the intersection, most of the crashes were associated with rear-end collisions or turning movements. There are no roadway geometric deficiencies associated with this interchange so the cause of these crashes is undetermined. However, it should be noted that the intersection is unsignalized.

- I-80 Mainline between the IL 84 Interchange and the Mississippi Rapids Rest Area Exist Ramp A total of 44 crashes (excluding 13 animal-related crashes) occurred along this section of I-80. Crashes classified as Fixed Object that are associated with vehicles running of the roadway represent 37% of the crash types. These crashes could be attributed to the deficient curve.

- I-80 Eastbound Exit Ramp to I-88 Eastbound Seven crashes occurred on the first 600 feet of the ramp's curve, which is a deficient curve. All the crashes involved trucks with the crash types involving overturned vehicles (4) or vehicles that ran off the road and hit a fixed object (3). All but one of the crashes involved an injury. These crashes could be attributed to the deficient curve.
